THE FACADE OF THE CHURCH OF SAINT FRANCIS OF BENIGANIM: THE STUDY DURING ITS RESTORATION

Luis Cortés Meseguer ^a, José Pardo Conejero ^b

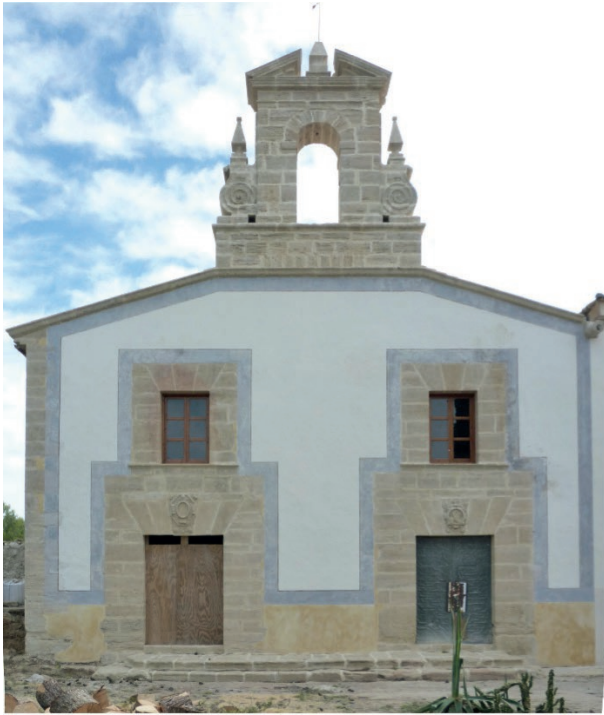
Fig. 12. View of the west or main façade. Final state. (Source: the authors).

The main façade, that of the church and the west wing of the convent, presented a deplorable state prior to the work, the result of unfortunate interventions and decades of neglect. A white plastic paint covered it completely; the numerous gaps in the lining had been filled with grey cement

mortar and the remains of the stone rendering had been almost completely chipped and removed. Thus, the previous state presented many losses, motivated by the following hypotheses:

The gaps in the upper parts and side of the epistle were due to the presence of humidity derived from the incorrect waterproofing of the stone slopes of the “imafronte”. In the specific case of the epistle, the more than probable blockage of the channel and scupper that solves the meeting of the south skirt of the roof with the high wall of the west cloistered wing aggravated these damages.

The gaps in the lower parts owed their cause to the capillary humidity that ascends through the walls. Above all, it occurred at both ends of the façade and to a lesser extent in its central part. The general lack of cladding in the ashlar masonry can be explained by two reasons: one could be the intentional chipping to leave the stone visible; the other, the lack of grip, after the passage of years, between the fine render and the sandstone, which caused it to lack adherence and disappear.

The belfry presented a very worrying appearance: a large part of the mortar on its joints had disappeared and some of its ashlars were in danger of falling off. It showed rooted vegetation in the joints of his factory and numerous lichen stains and general dirt. On its back, a large scratch recounted previous layouts and patches on the cover. In another order of things, the oxidation of the iron cross had partially burst the central pinnacle and the weathervane placed in the postwar period had disappeared.
