The aftermath of the Emilia 2012 earthquake damages and the safeguard of the rural anthropized landscape

Manlio Montuori

Department of Architecture, University of Ferrara, Ferrara, Italy.

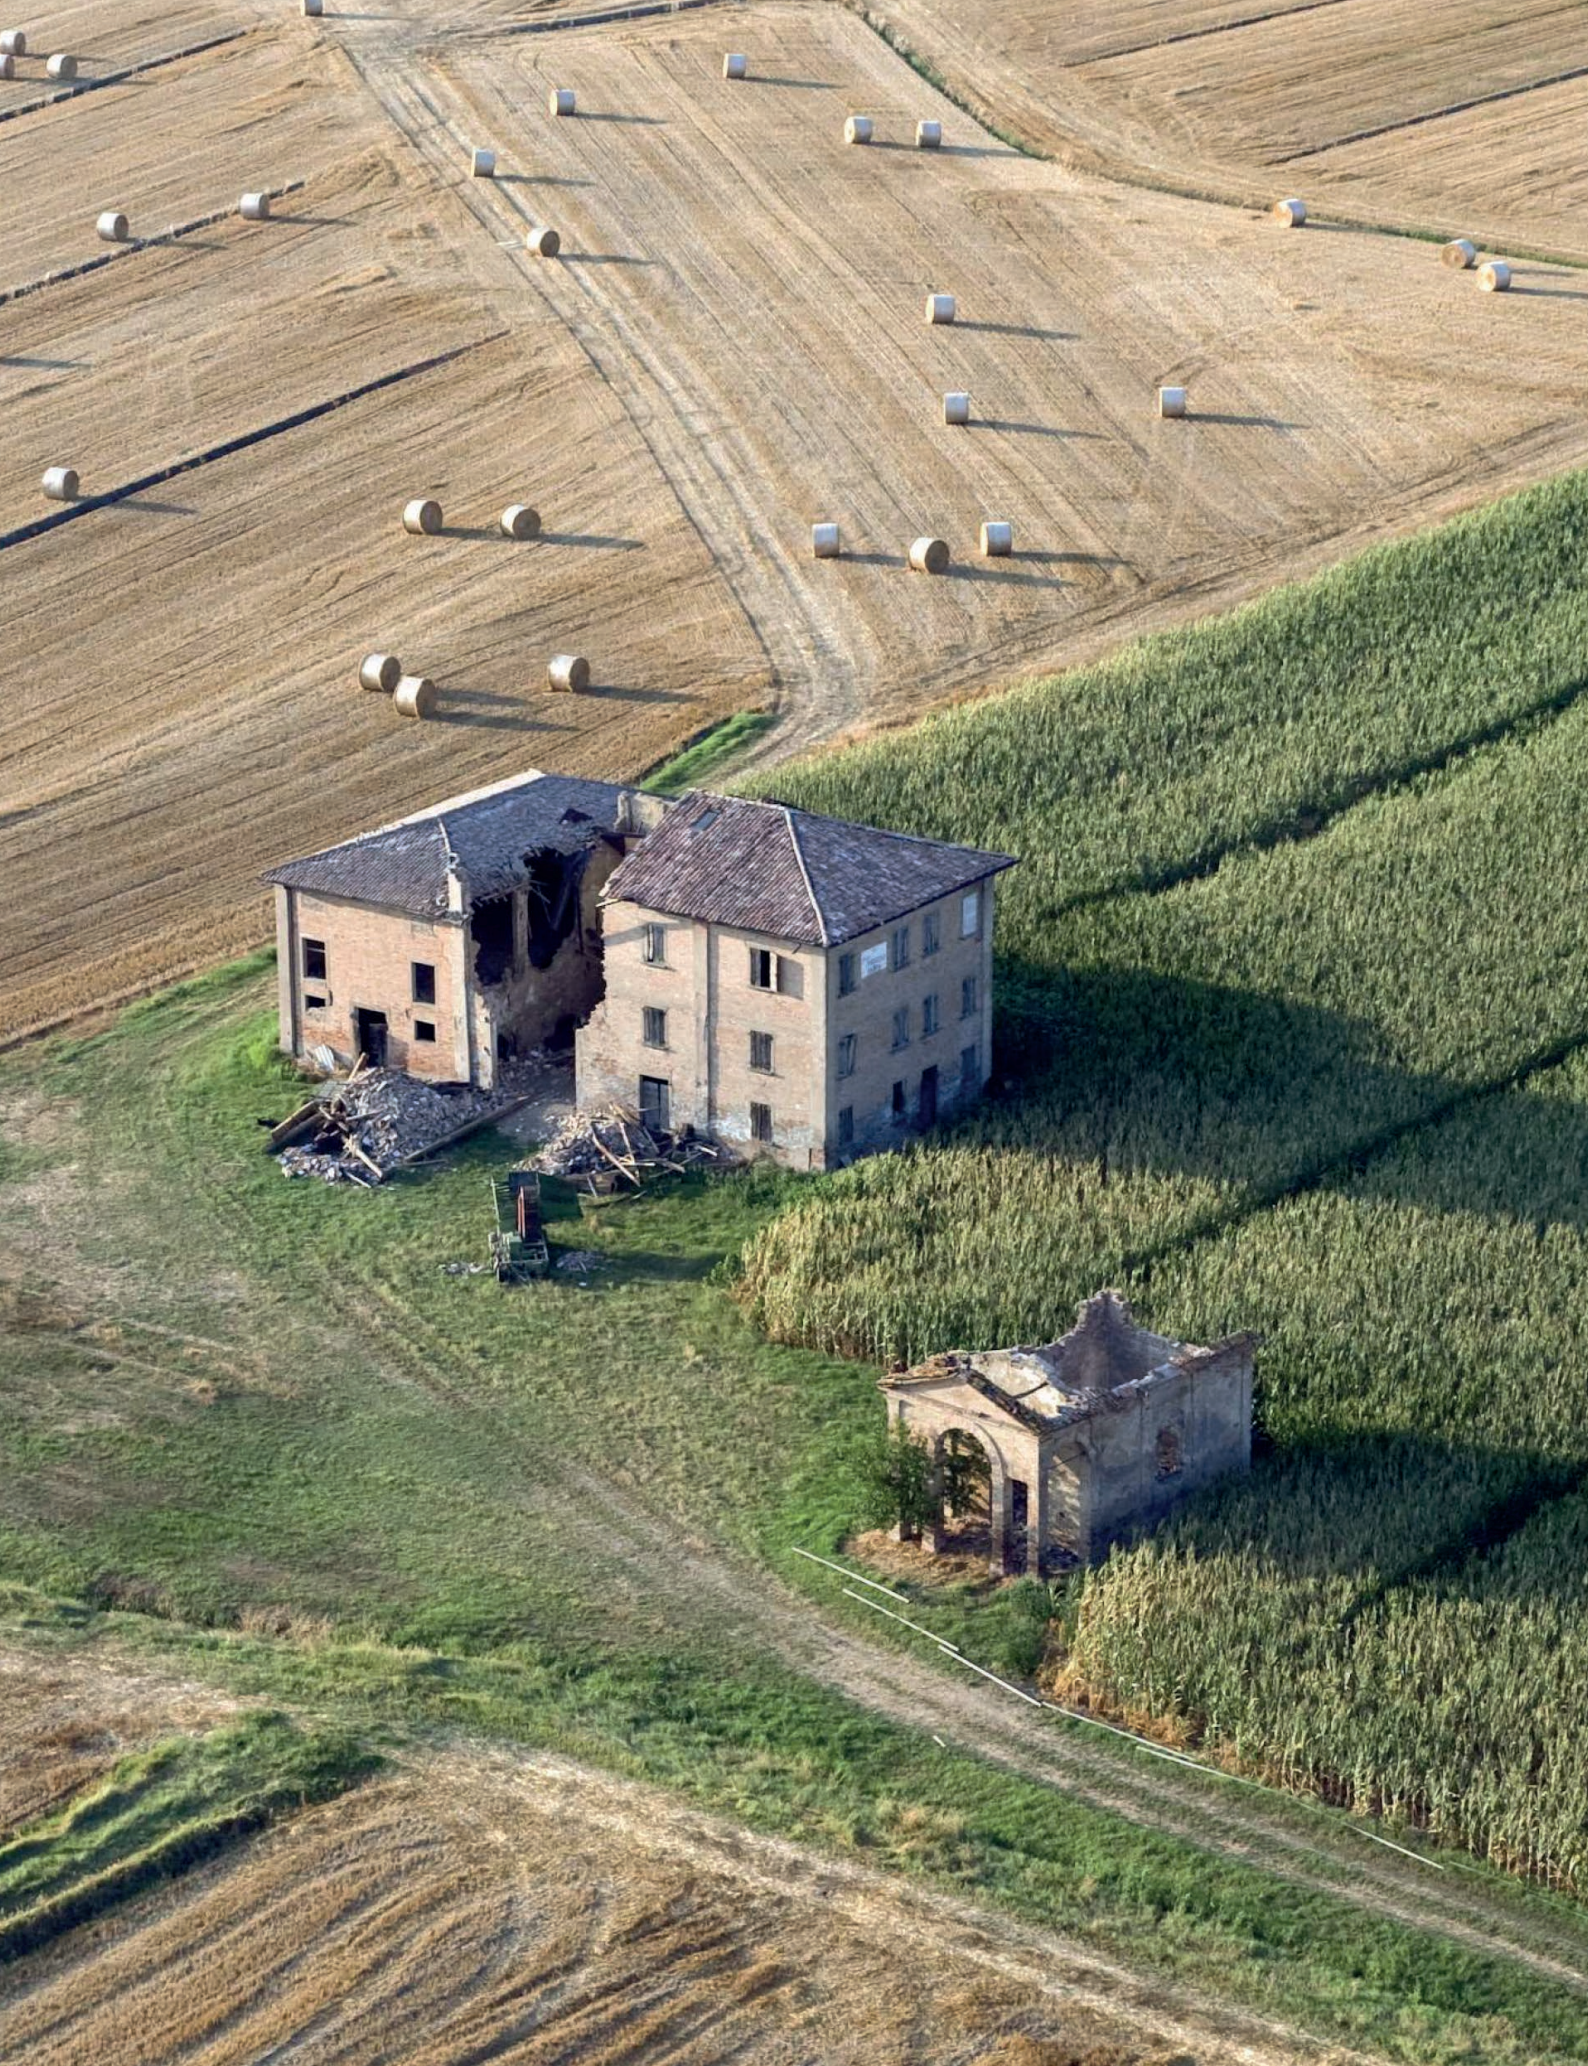
Finale Emilia, Modena. Tenuta Campa. The collapse of the timber roofs mainly caused the damages suffered by the rural dwelling and its annexed oratory.

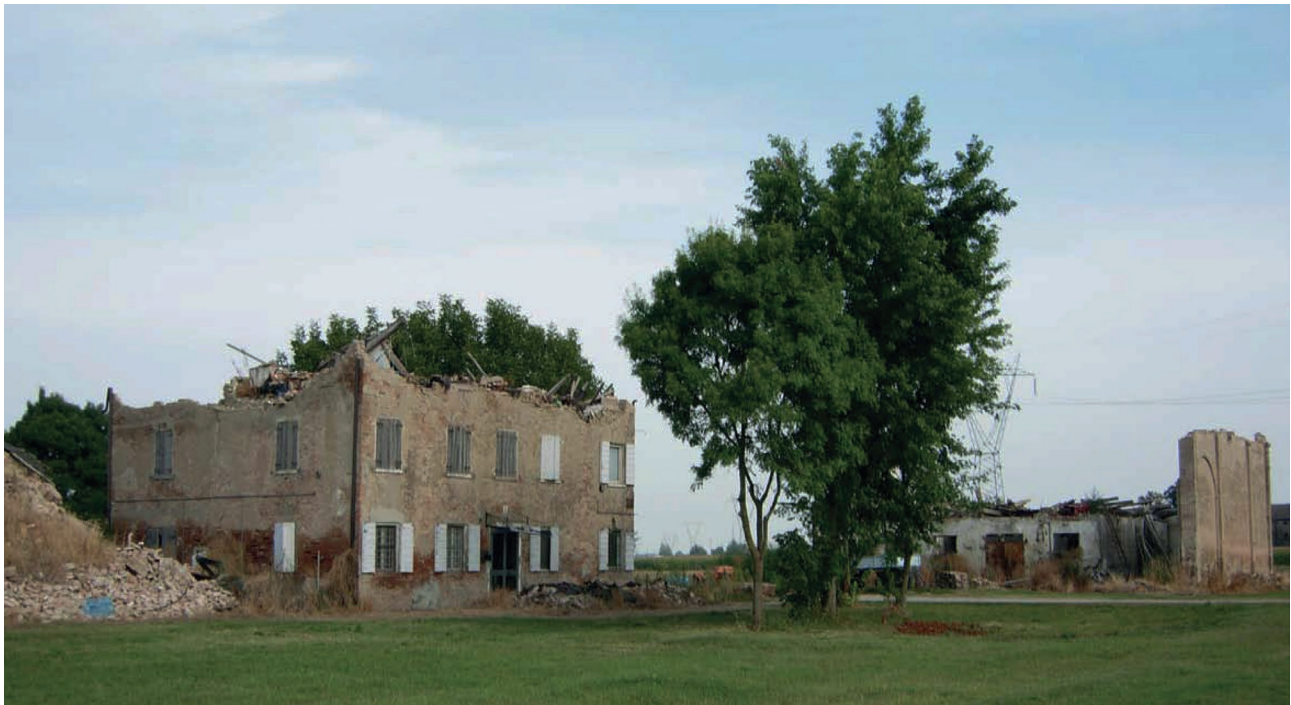
Figure 1 | San Giacomo Roncole in the district of Mirandola, Modena. In the historic courtyard, the stable-barn and the dwelling collapsed due to wall-roof interaction.

The images that, in the aftermath of the recent seismic events that struck Italy, most remain imprinted in the collective memory – e.g., the devastation of Amatrice and forms of Parmigiano-Reggiano damaged due to the collapse of scalere in Emilia-Romagna (Agenzia di informazione..., 2013) – perhaps more than any other thought give the idea of how every earthquake is a unique event in its kind, addressed by many variables: the energy released, the extension of the involved area, the natural, social and economic characteristics of the territories. All of this results in significant variability of damage that the seismic event produces, in the impact of the short and long period on the territory, in emergencies, and in the way, the return back to normality is faced (Fig. 1).

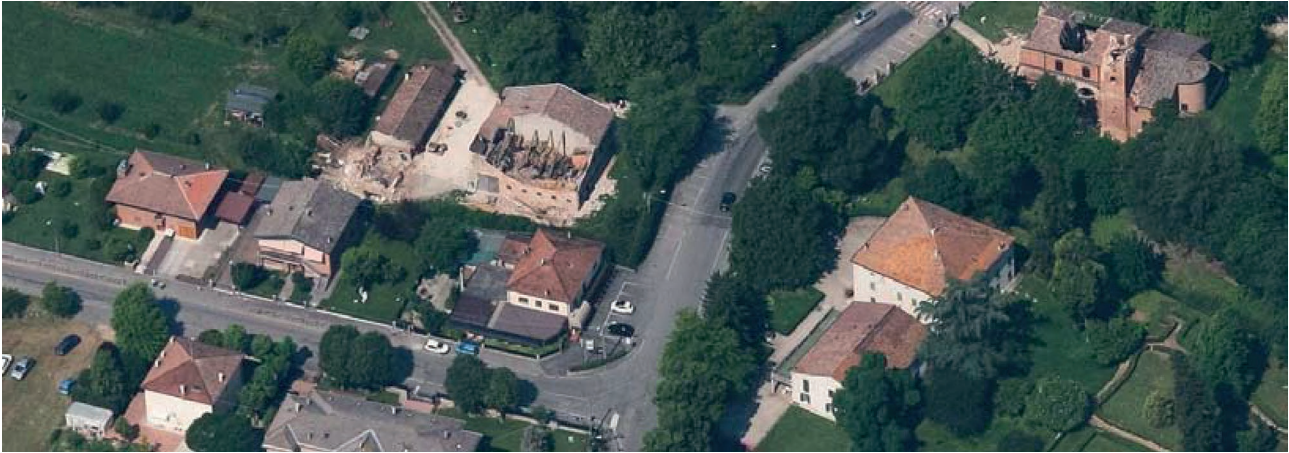
Figure 2 | Medolla, Modena. The roof, resting on long span walls, collapsed and directly contributed with its thrust to the out-of-plane overturning of the walls.

significant horizontal actions. Actually, this overall positive behaviour failed due to various factors, not surprising for a spontaneous construction, directly linked to the construction techniques (e.g., lack of connection between orthogonal walls, concentrated action of the beams either on the floors or the roofs, different load amount on orthogonal walls, the lintel thrusts above the openings) that lead to the overturning mechanism of the facade wall detached from the orthogonal ones and the separation of the same walls in autonomous vertical bands. Thus, the so-formed separate portions of the masonry rotated outwards due to the eccentricity of the thrusting as a consequence of the perimeter walls shape, whose offsets are all arranged from the inner side. The stables and the barns showed the most considerable damage, in many cases triggering the collapse, due to the critical relationship between the height and the thickness of the walls, accentuated by the length/thickness ratio of the long walls, especially in the barns and the *barchesse* that, in addition, have highly irregular configurations, both in plan and elevation. The very slender infill walls are frequently out-of-plane collapsed, mainly when laid in a stretching bond, and if pillars are present, the connection between the pillars and the infill wall proved to be ineffective. The out-of-plane failure mechanisms also involved thicker perimeter walls, especially in the absence of transverse walls. In these cases, the roof, resting on long-span walls, collapsed and directly contributed with its thrust to the out-of-plane overturning of the walls.

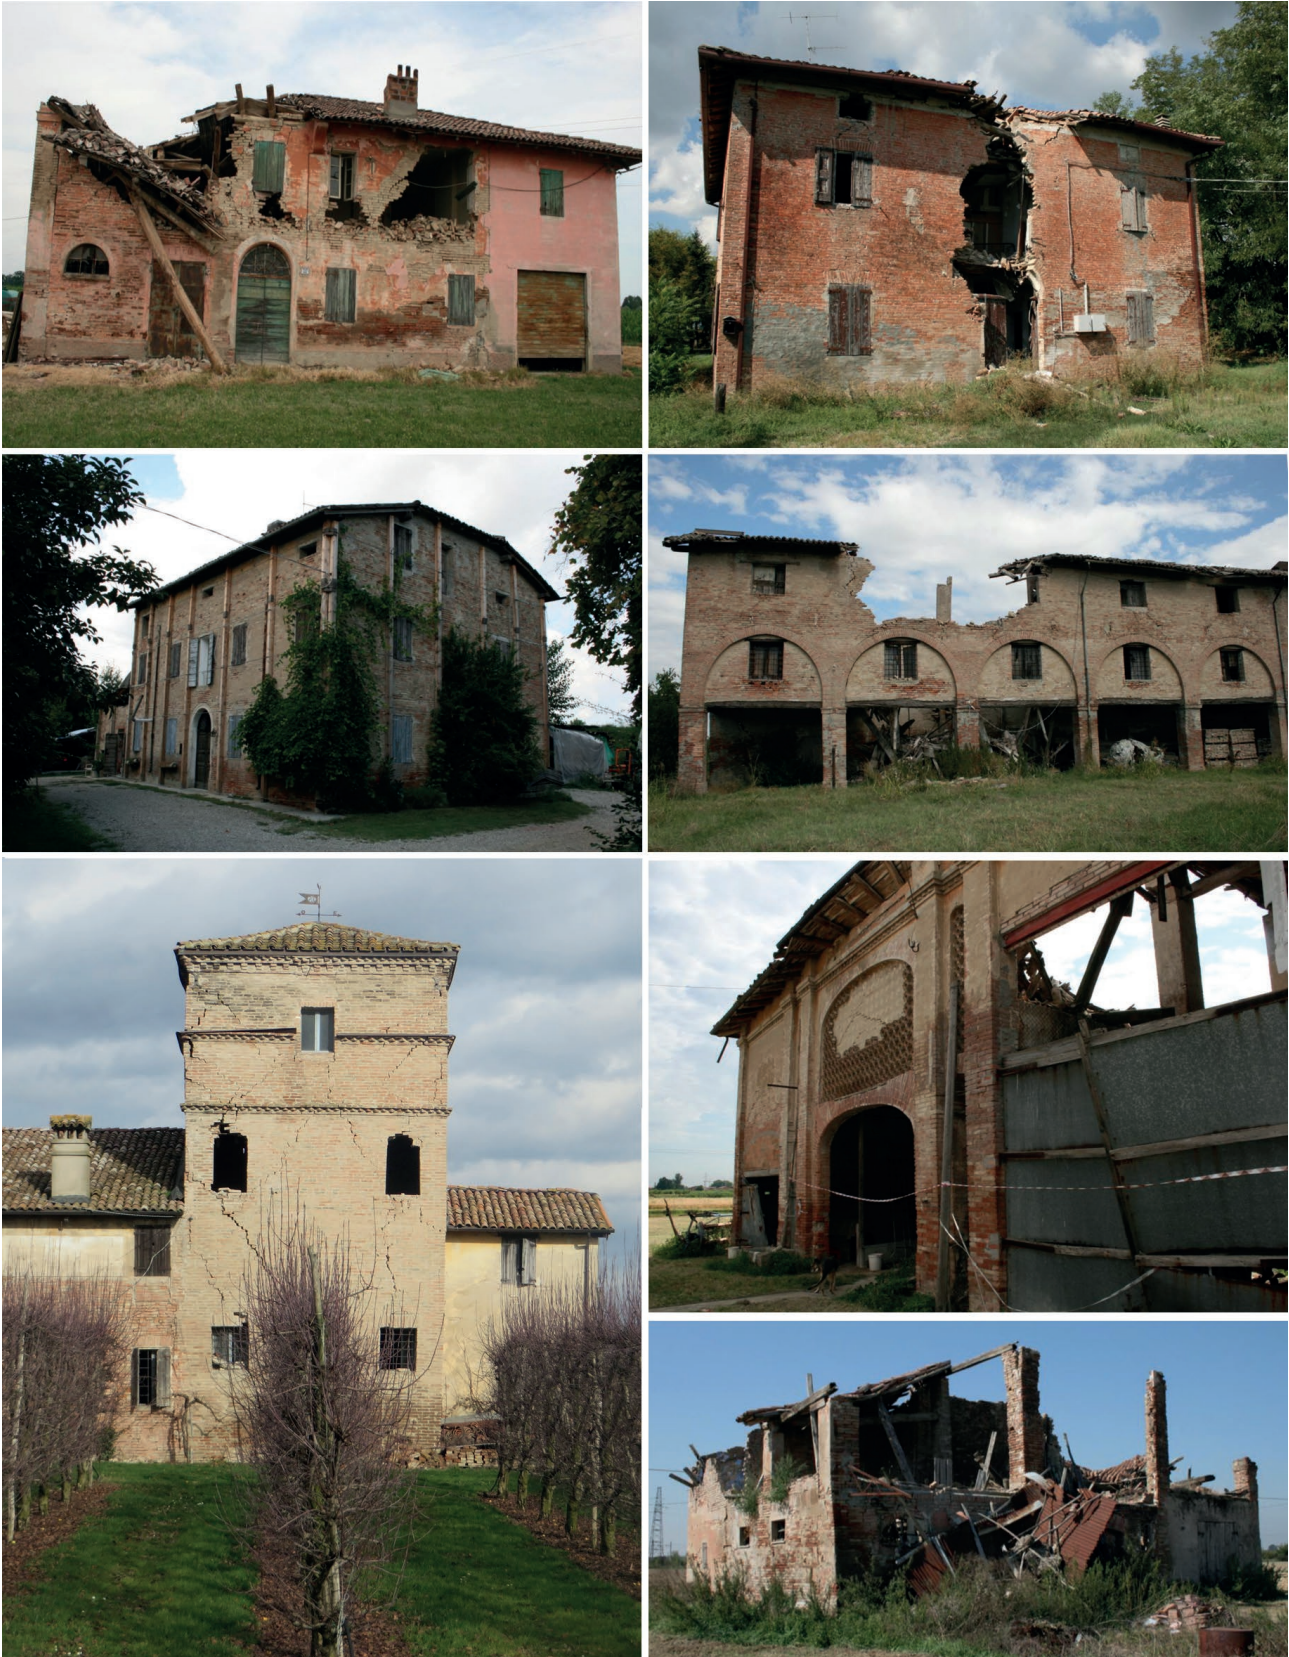
Figure 3 | Spontaneous built heritage at the earthquake test: Crevalcore, Bologna (top, centre, and bottom-right); San Felice sul Panaro, Modena (bottom-left).
