THE FACADE OF THE CHURCH OF SAINT FRANCIS OF BENIGANIM: THE STUDY DURING ITS RESTORATION

Luis Cortés Meseguer ^a, José Pardo Conejero ^b

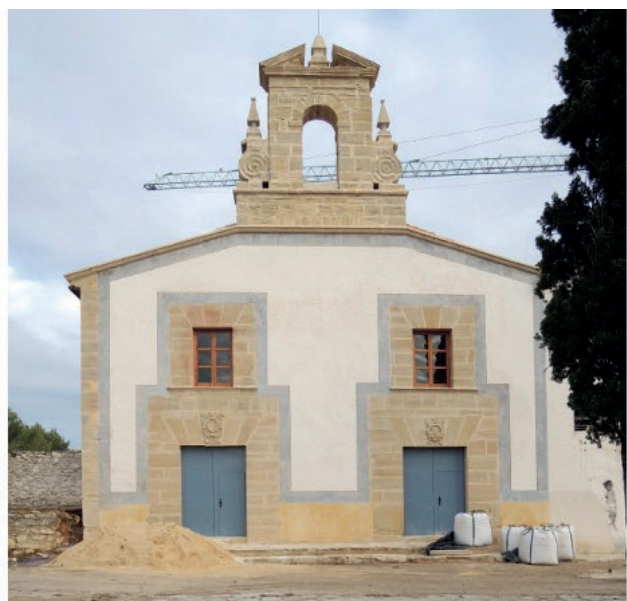
Fig. 1. Facades of the convent of San Onofre de Xàtiva (left) and the convent of San Francisco de Benigànim (right) (Source: authors, 2019).

The main façade, that of the church and the west wing of the convent, presented a deplorable state prior to the work, the result of unfortunate interventions and decades of neglect. A white plastic paint covered it completely; the numerous gaps in the lining had been filled with grey cement

mortar and the remains of the stone rendering had been almost completely chipped and removed. Thus, the previous state presented many losses, motivated by the following hypotheses:

The gaps in the upper parts and side of the epistle were due to the presence of humidity derived from the incorrect waterproofing of the stone slopes of the “imafronte”. In the specific case of the epistle, the more than probable blockage of the channel and scupper that solves the meeting of the south skirt of the roof with the high wall of the west cloistered wing aggravated these damages.

The gaps in the lower parts owed their cause to the capillary humidity that ascends through the walls. Above all, it occurred at both ends of the façade and to a lesser extent in its central part. The general lack of cladding in the ashlar masonry can be explained by two reasons: one could be the intentional chipping to leave the stone visible; the other, the lack of grip, after the passage of years, between the fine render and the sandstone, which caused it to lack adherence and disappear.

The belfry presented a very worrying appearance: a large part of the mortar on its joints had disappeared and some of its ashlars were in danger of falling off. It showed rooted vegetation in the joints of his factory and numerous lichen stains and general dirt. On its back, a large scratch recounted previous layouts and patches on the cover. In another order of things, the oxidation of the iron cross had partially burst the central pinnacle and the weathervane placed in the postwar period had disappeared.

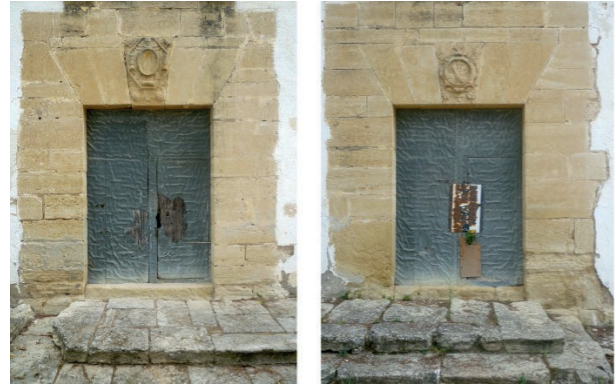
Fig 10. View of the two emblazoned portals (left north nave; right south nave) (Source: the authors).

The entire façade was rendered with lime mortar, including the sandstone masonry, a detail that at first went unnoticed.

The façade was not white, but presented a simple polychromy based on three colours: broken white, grayish blue and sienna. The background was made up of an off-white, made with a paint or patina of lime.

Thirdly, the façade facing is completely smooth and devoid of any properly architectural ornamentation. Their order and pattern are determined by the pictorial decoration. The recent intervention has allowed the discovery of these remains, their enhancement and the recovery of their original image. This decoration is based on the following aspects:
