Avoiding failures during building construction using structural fuses as load limiters on temporary shoring structures

Manuel Buitrago^a, Juan Sagaseta^{b*}, Jose M. Adam^a

Keywords: *Building; Damage; Load limiter; Progressive collapse; Slab; Steel Shore; Structural fuses.*

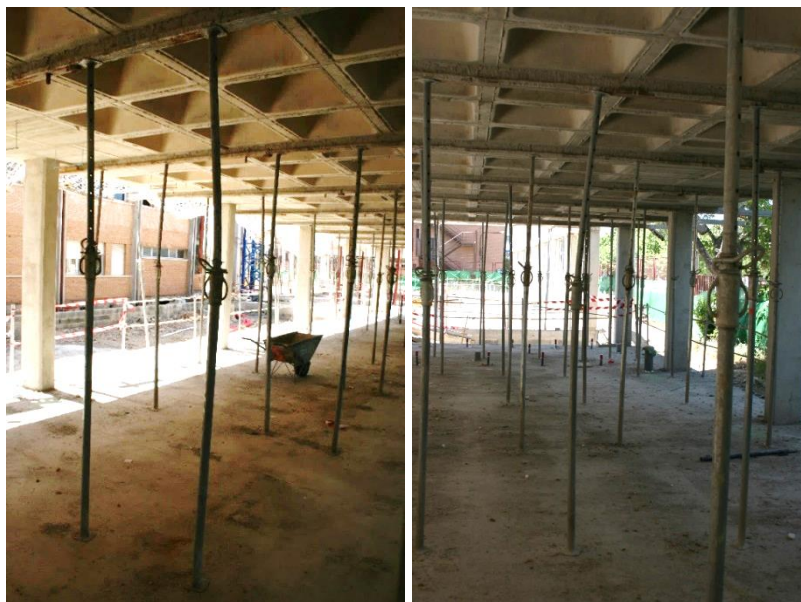
Fig. 1. Shore buckling during the construction of a building structure.

81 In many of these reported accidents the failure occurred in the shoring system. An example
82 is shown in Fig. 1, in which many of the shores buckled due to overloading. Shore buckling,
83 together with pin deformation or breakage, are the most frequent mode of failure observed [31].
84 It is also observed that other shores in Fig. 1 that appear to be undamaged did not carry any load
85 after the incident. In the case shown the permanent structure did not collapse, however other cases
86 have been reported in [9] where such incident have led to the progressive collapse of the entire
87 structure. The concept of progressive collapse is understood as the process by which local damage
88 sets in motion a chain of failures, leading to the collapse of the entire structure or a large part of
89 it [32].

92 A potential issue in cases as the one in Fig. 1 in which the integrity of the permanent structure
93 was not affected is the consequences during the service life of the building. A serious concern in
94 many of these cases is that the initial damage might not be detected and the structure will be put
95 into service without any repair being considered. This scenario is plausible in cases where there
96 is a lack of supervision. For example, an investigation in the UK commissioned by the HSE [33],
97 which included site investigations and interviews with those involved in procurement, highlighted

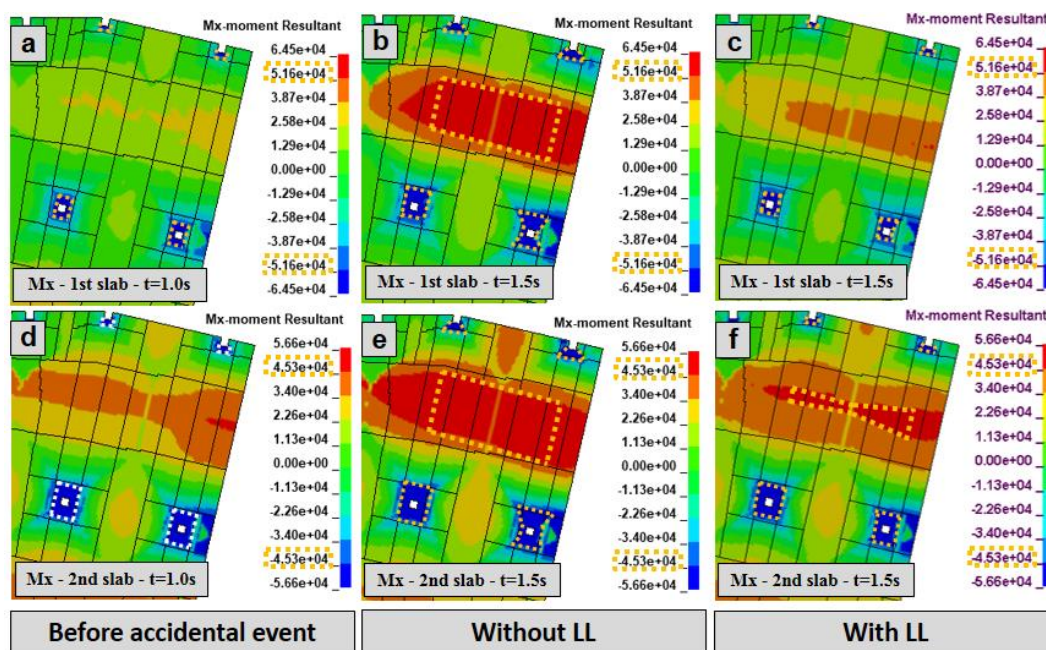
323
 324 **Fig. 11. Bending moments of first slab (a, b and c) and second slab (d, e and f) before (a and d) and**
 325 **after (b, c, e and f) the accidental event without (b and e) and with (c and f) load limiters (LL) for**
 326 **the 3rd failure scenario (units in N).**

318 heavily loaded shore on the ground floor. Without LLs, the slope of these curves (flexural
 319 stiffness) reduced significantly when the progressive collapse of the shoring system began. With
 320 LLs, excessive cracking was prevented and the slope remained relatively constant (linear
 321 behaviour). Fig. 11 shows the reduced cracking due to the LLs. The cracking bending moments
 322 in the slab were 51.6kN and 45.3kN for the first and second slabs respectively.

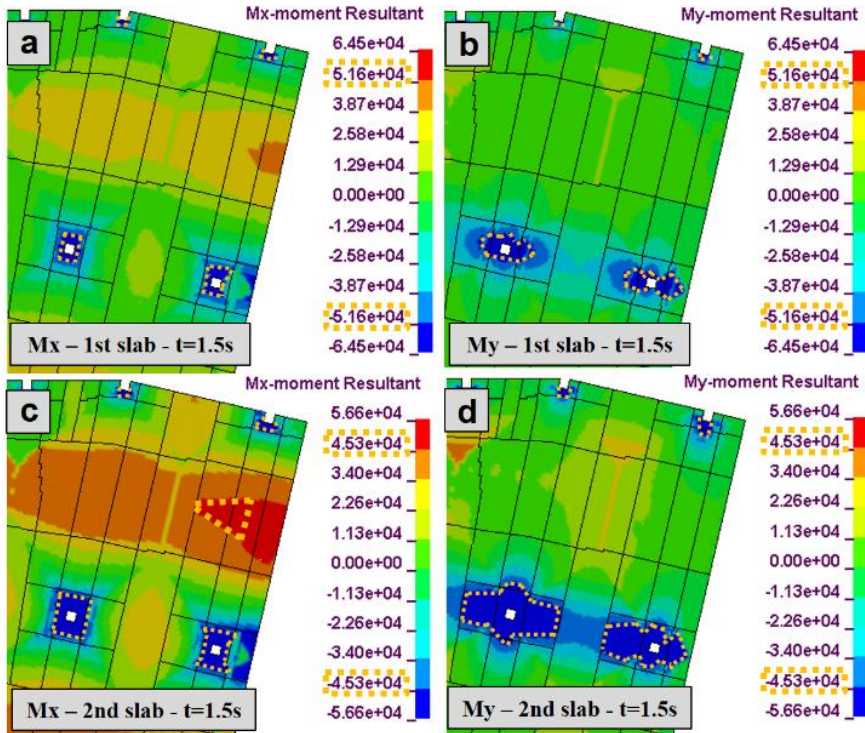
Fig. 17. Bending moments of slab (a and b) and second slab (c and d) using load limiters (units in N).

395 Fig. 16 shows the cracked areas in the slab in the case without LLs (enclosed by broken lines
396 for Bay A2-B1 under study). The cracking bending moments in the slab were 51.6kN and 45.6kN
397 for first and second slabs respectively. Fig. 17 shows the cracked areas for the case with LLs
398 which is significantly reduced compared to the case without LLs in Fig. 16. These results show
399 the potential of using LLs. Selecting the incorrect type of shore is not uncommon and it can also
400 represent cases of unexpected live loads during construction for which the shores are not designed
401 for. The LLs could act as a simple risk mitigating measure to protect against the effects of
402 uncertainty of construction loading.

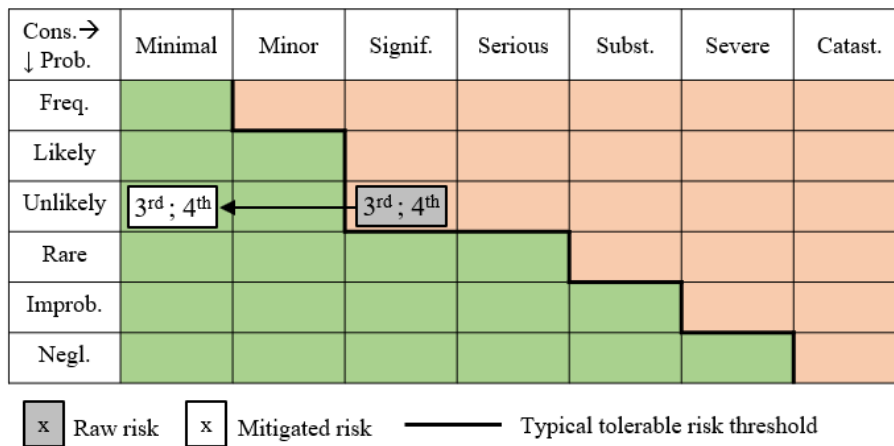
457 **Fig. 19. Analysis of raw and mitigated risk after introducing LLs for the 3rd and 4th failure**
 458 **scenarios; risk matrix based on [49] (green: tolerable risk; red: intolerable risk).**

437 A systematic risk assessment of the structure is shown in Fig. 19 using the consequence class
 438 obtained from the structural analysis and the probability of occurrence for the “unlikely” class
 439 which corresponds to a 10% probability of occurrence during the design life [49]. Probability
 440 class “likely” corresponds to 50% and “rare” is for 2% probability. The probability of occurrence
 441 of the 4th failure scenario (between 6% to 26%) can be slightly higher than for the 3rd failure
 442 scenario (between 3% to 18%) depending on the causes as discussed in more detail in [9,17]. The
 443 adopted probability class is consistent with the one used in the example building in the IStructE
 444 manual for the hazard identified as failure of temporary works during construction [49]. The black
 445 line shown in Fig. 19 shows a typical tolerable risk threshold used in the IStructE manual [49]

446 which is roughly consistent with Annex B in EN 1991-1-7:2006 [50]. Fig. 19 shows that the raw
 447 risk of failure of the shoring system is very close to the threshold which is undesirable. The
 448 situation can worsen depending on the role of the slab where the damage takes place affecting the
 449 severity of the consequence from “minor/significant” to “significant” in Fig. 19. For example, as
 450 reported in [49], for transfer slabs in ground floors damage on the member can have significant
 451 implications.

452 Fig. 19 shows that introducing the LLs on the shores will shift the risk (mitigated risk) into
 453 the tolerable risk represented by the green boxes in the risk matrix. A cost-benefit analysis is
